DEPARTMENT OF METALLURGY
AND MATERIALS SCIENCE

HOT CORROSION OF HIGH
TEMPERATURE ALLOYS.

JOHN STRINGER

Final Scientific Report : 15 May 1972-14 May 1975.

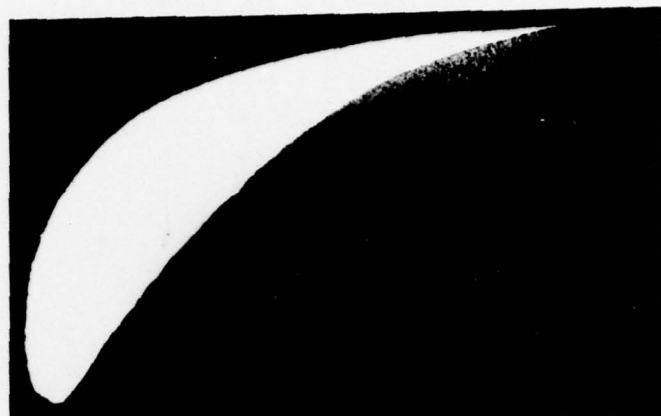
An unetched section of a similar blade in a badly affected region.

Figure 1(a) shows the concave surface of a Nimonic 100 first-stage turbine blade from an Olympus engine after 401h running at approximately 870°C. Figure 1(b) shows a section of a similar blade, and Figure 1(c) shows the corrosion product at higher magnification. There is an outer oxide layer, rather porous; an intermediate layer of mixed oxide and metal, and finally an inner layer consisting of fine lighter-grey particles in a metal matrix. This innermost layer is shown in more detail in Figure 1(d). All these figures are taken from Smith et al (7). The outer oxide layer is essentially NiO, with some NiCr_2O_4 spinel. The intermediate layer is essentially Ni-rich fragments in a Cr_2O_3 matrix although again there is some spinel. The light grey particles are chromium-rich sulphides, and the metal in the inner layer is depleted in chromium. Very similar pictures of the corrosion of 713C blades operated in the Pacific for 600h are shown by Schirmer and Quigg (16).

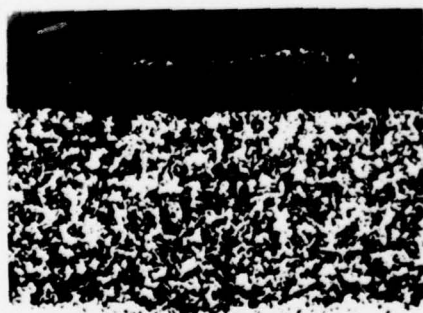
Figure 1(c)

The corrosion product morphology: an outer layer of porous oxide, a thick layer of mixed metal and oxide, an inner layer of fine sulphide particles in a metal matrix. (x 250)

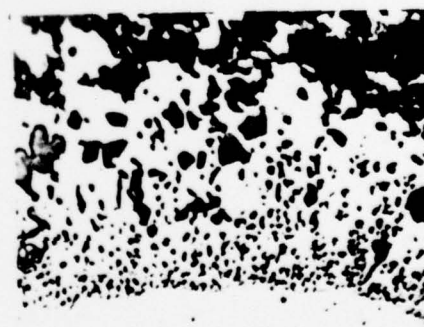
Figure 1(d)

The innermost layer, showing the sulphides. It is clear that the oxide particles have been formed by the oxidation of the sulphides. (x 1050) All these figures are from Smith et al (7).

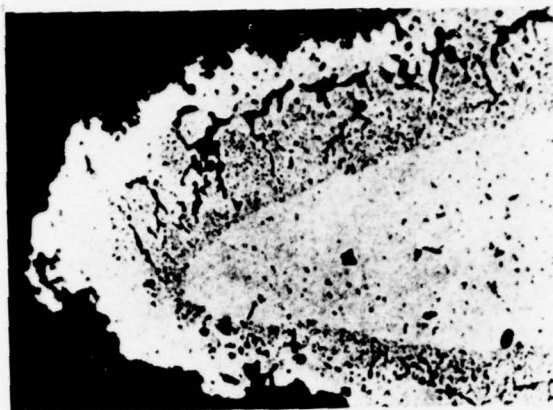
Figure 2 Heavy internal sulphidation at the trailing edge of an originally pack aluminised Nimonic 105 turbine blade from a Proteus engine. From Condé (6) (Crown Copyright Reserved).

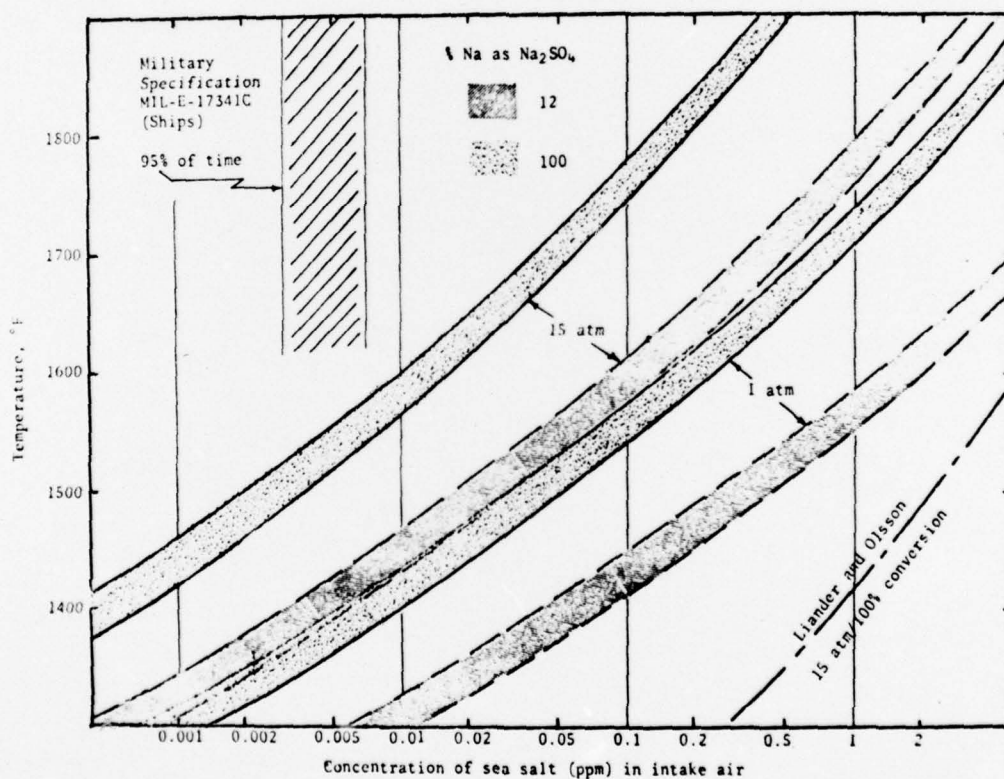
Figure 3 Condensation temperatures for Na_2SO_4 as a function of concentration and pressure. From Bessen and Fryxell (23).

Besson and Fryxell (23) redetermined the vapour pressure of Na_2SO_4 , and found that the values used by DeCrescente and Bornstein for their calculations were too high: Figure 3 shows dew points calculated using their vapour pressure data for two pressures and for complete sulphation of the NaCl and zero sulphation (i.e., all the Na_2SO_4 was that already present in the original sea salt). These results are much closer to engine experience, but it must be remembered that the salt concentration in the gas entering the combustion chamber may not be simply related to that entering the engine, and that much of it may not evaporate into the gas phase anyway. Besson and Fryxell also point out that if the engine is power cycled, salt may deposit at the lower temperatures and produce corrosion at the higher temperatures.

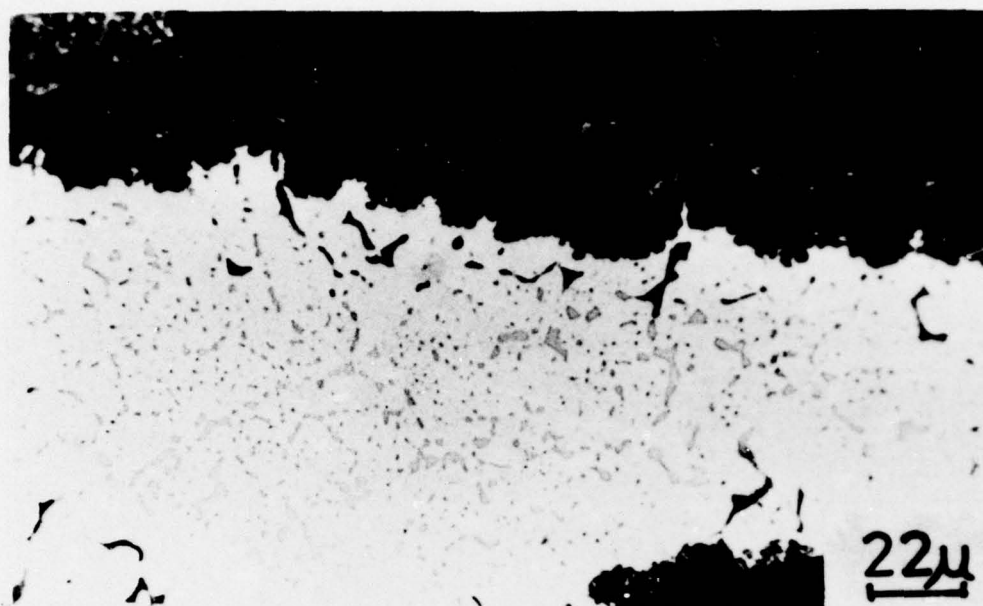
Figure 4 Heavy internal sulphidation of a Ni-15Cr-6 Mo alloy coated with $2.07 \text{ mg/gm}^2 \text{ Na}_2\text{SO}_4$ and oxidised for 22 hours at 900°C . Note the general similarity to Figure 2. From Peters et al (61).

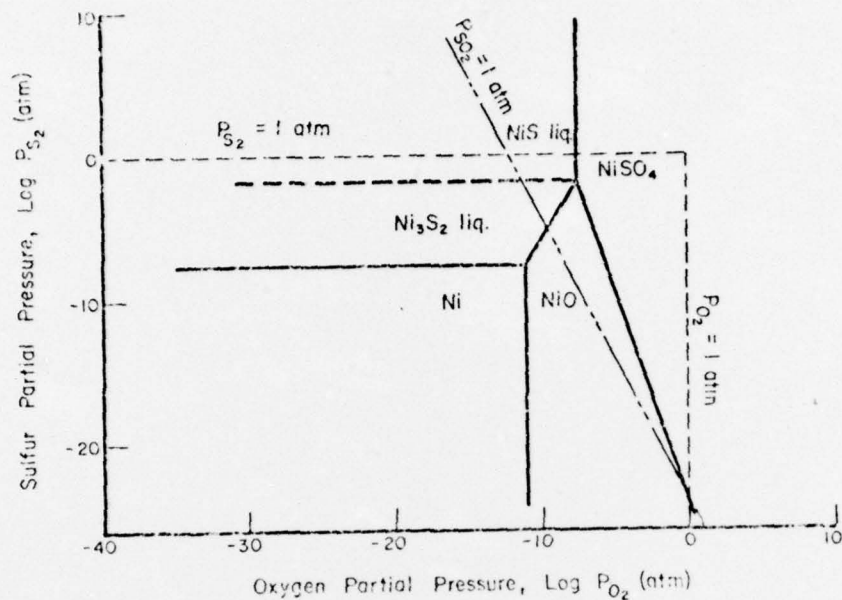
Figure 6 The phase stability diagram for the system Ni-O-S at 927°C. From Quets and Drescher (63).

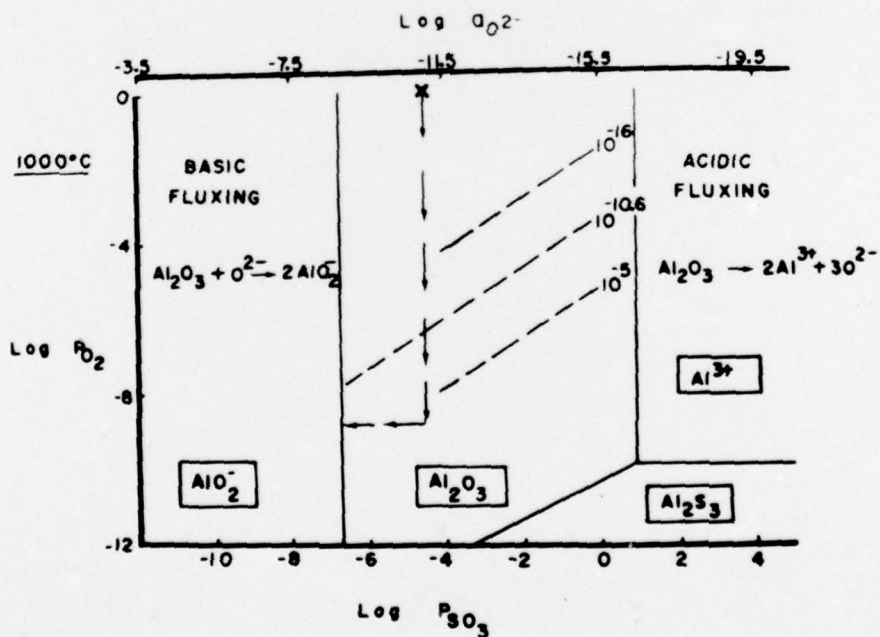
Figure 7 A phase stability diagram representing the phases in Al-O-S system that are stable in Na_2SO_4 at 1000°C. From Goebel et al (65).

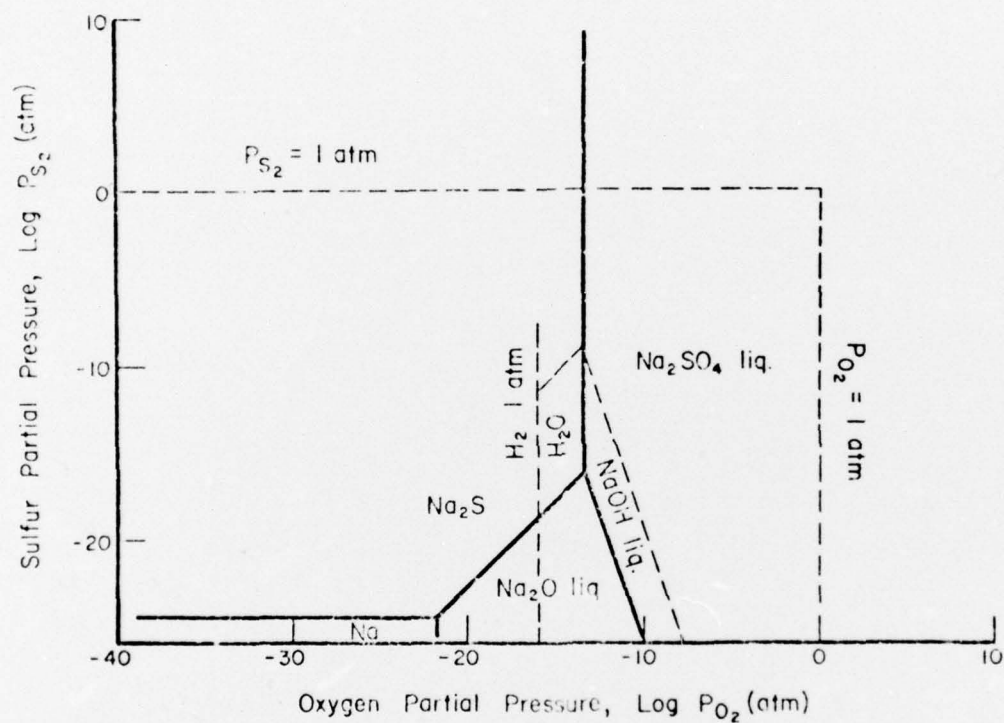
Figure 8 The phase stability diagram for the system Na-O-S at 927°C. From Quets and Drescher (63).
